## Boat-Wave-Induced Bank Erosion on the Kenai River, Alaska

Stephen T. Maynard, David S. Biedenharn, Craig J. Fischenich,  
and Jon E. Zufelt

March 2008

Final report

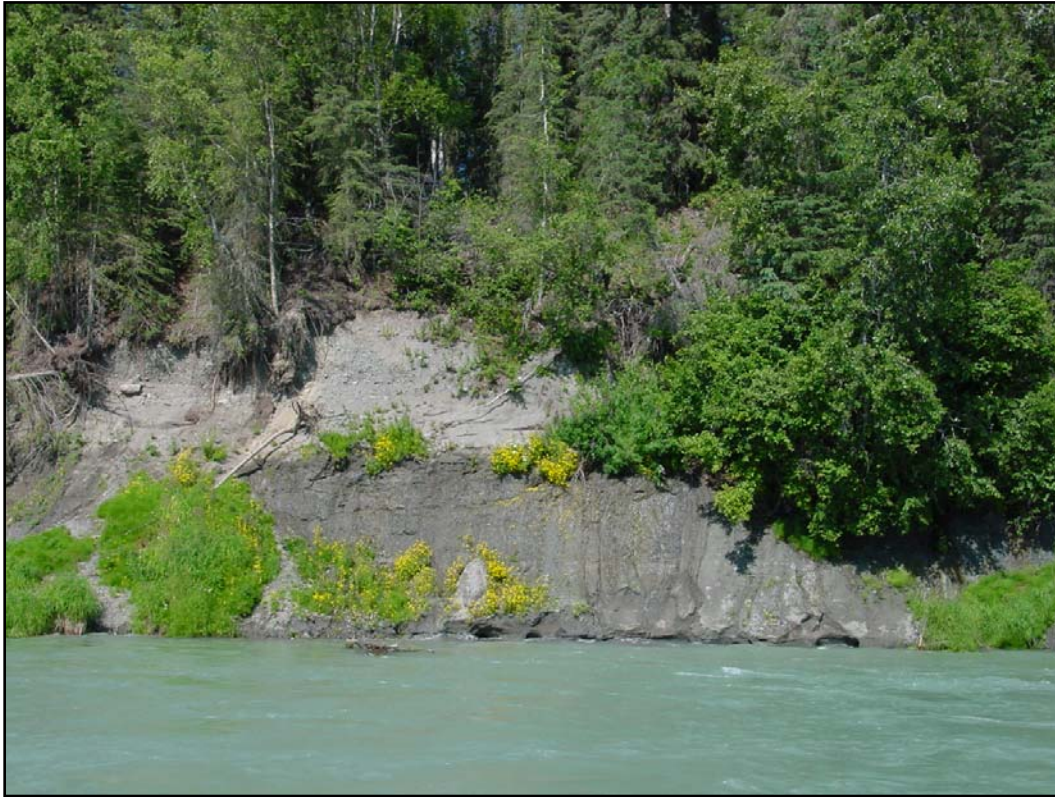
Figure 6. Typical failure of banks along the Kenai River includes loss of vegetative cover and increased erosion at water surface.

Bank erosion destroys important habitat in the riparian zone. Accelerated erosion rates have been observed along the Kenai River between Beaver Creek at RM 10 and the Soldotna Bridge at RM 21. Figure 6 shows an example of an eroded bank in this reach. A possible cause of this erosion has been attributed to increased boat traffic. In order to test the validity of

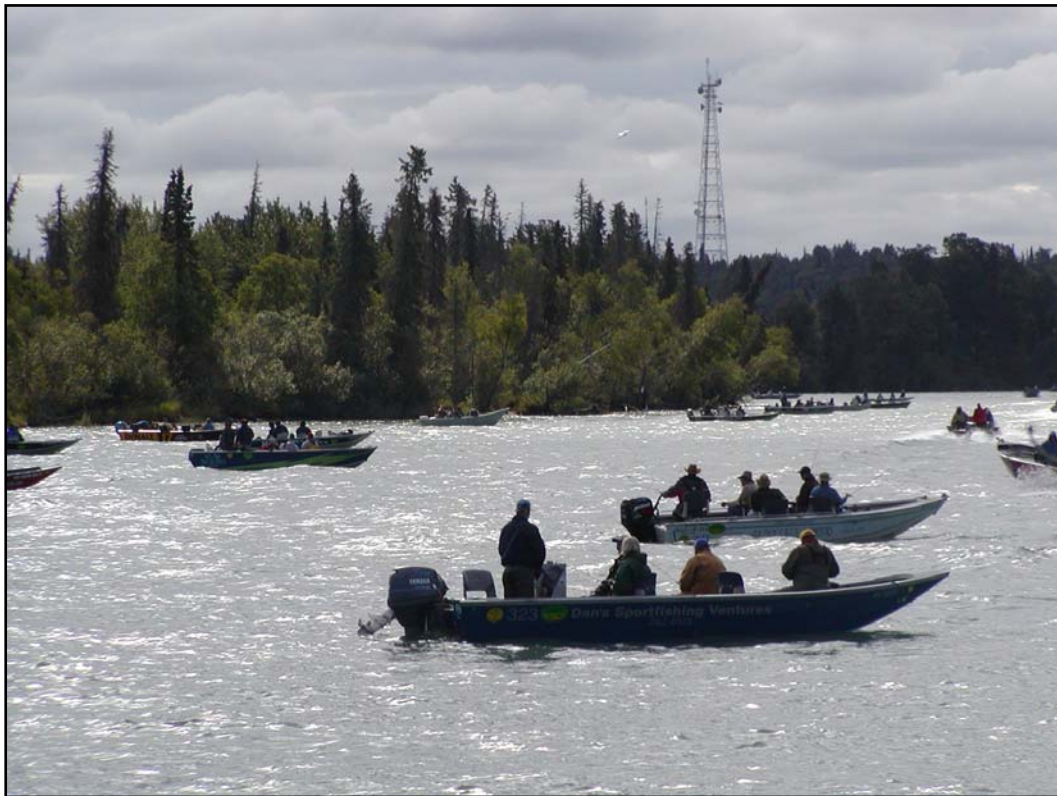
Figure 7. Kenai River, looking upstream from boat count and wave measurement site on right descending bank at RM 11.3. Picture shows the major drift area in the study reach. Boats generally drift down the right descending bank and motor up the left descending bank.

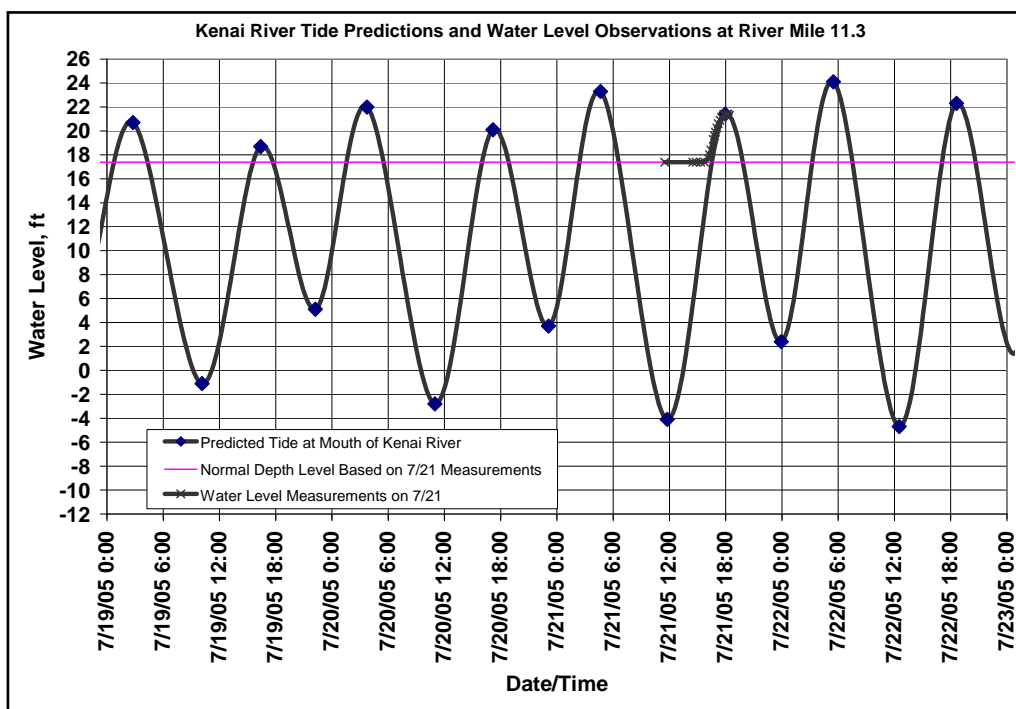
Figure 9. Kenai River tide predictions and water level observations at RM 11.3. Water level datum is the tide elevations at the mouth, which are not absolute elevations at RM 11.3. Minimum water level at RM 11.3 is the normal depth line.

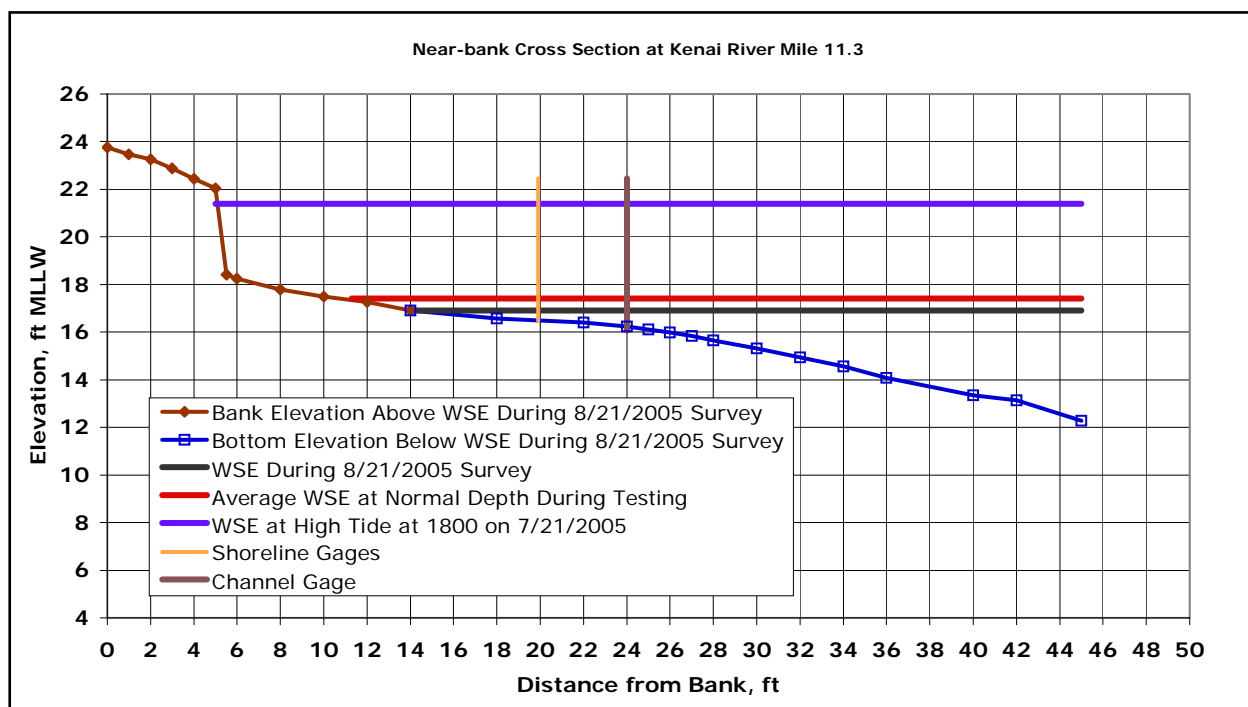
Figure 11. Near-bank cross section at RM 11.3, water surface elevations (WSE), and location of gages. Plot shows that maximum water level variation due to tides during testing on 21 July 2005 was about 4 ft.

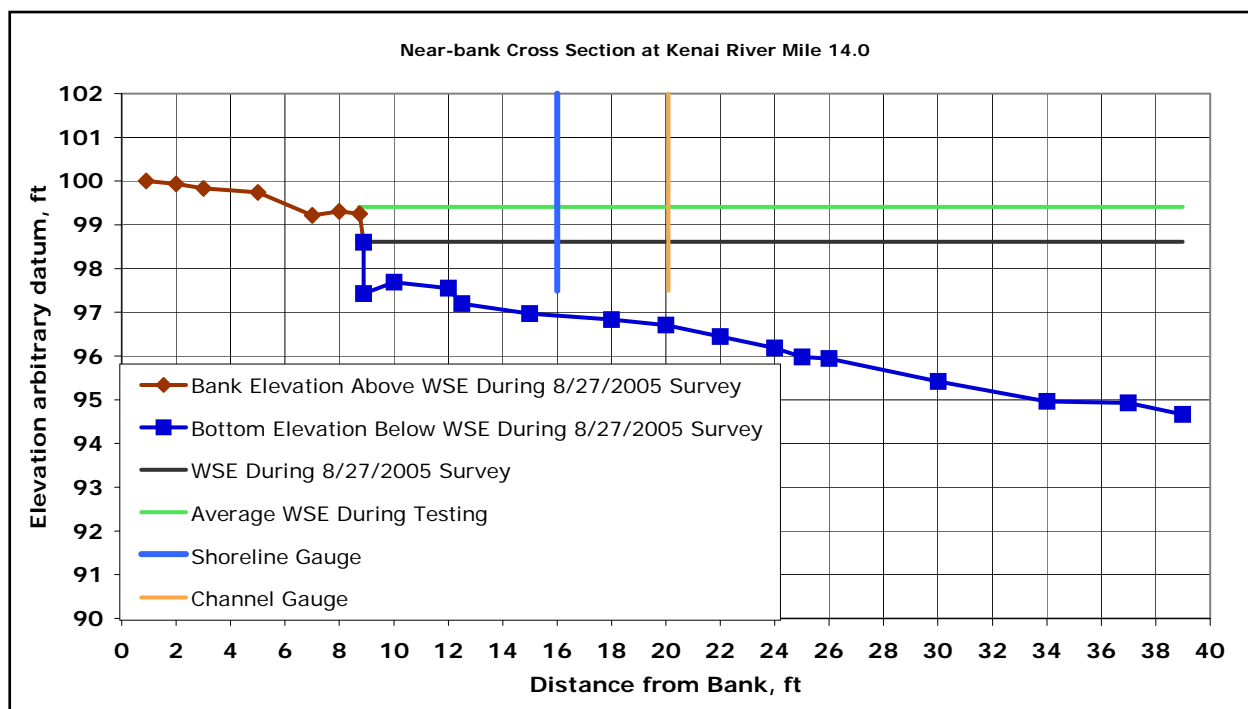
Figure 12. Near-bank cross section at RM 14.0, water surface elevations (WSE), and location of gages. No variation due to tides was present at this site.

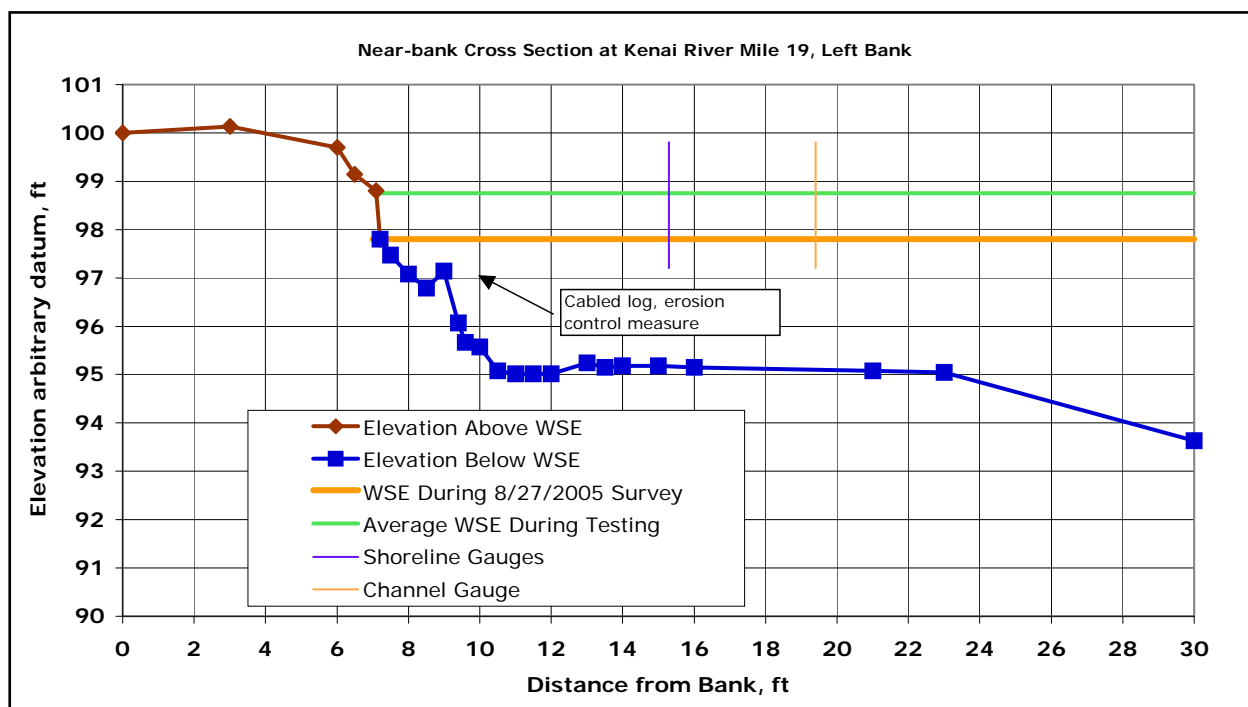
Figure 13. Near-bank cross section at left bank of RM 19.0, water surface elevations (WSE), and location of gages. No variation due to tides was present at this site.

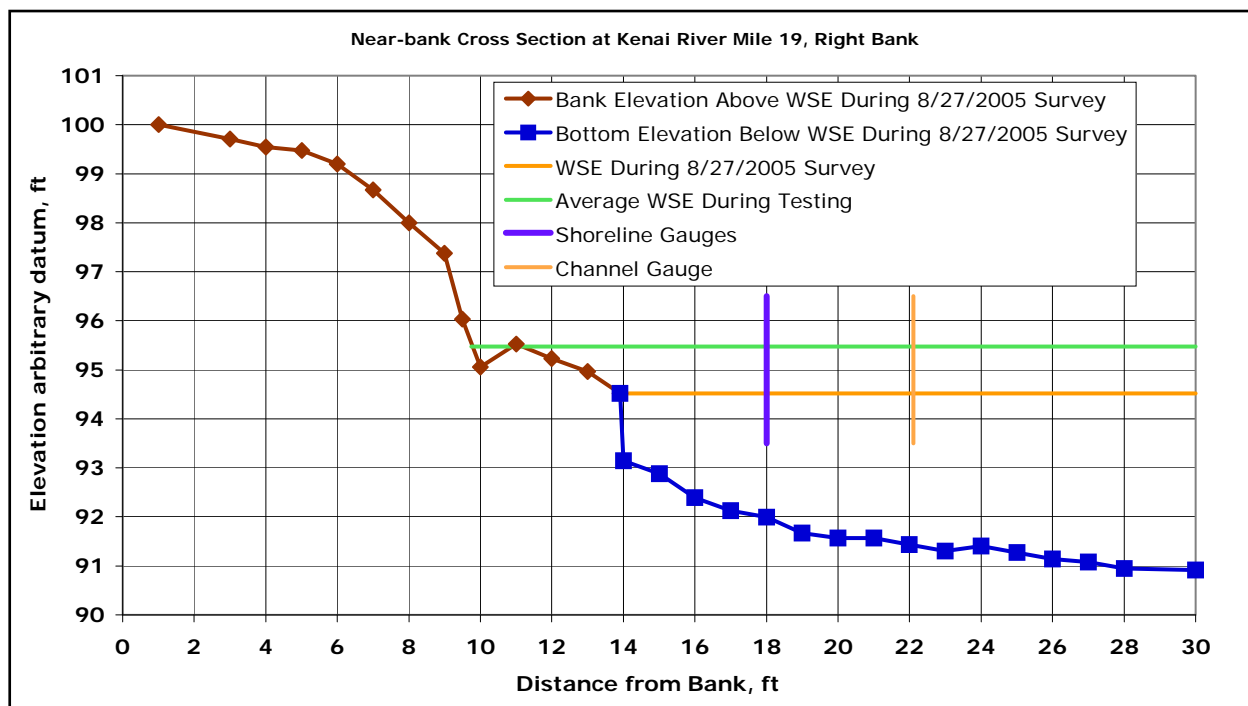
Figure 14. Near-bank cross section at right bank of RM 19.0, water surface elevations (WSE), and location of gages. No variation due to tides was present at this site.

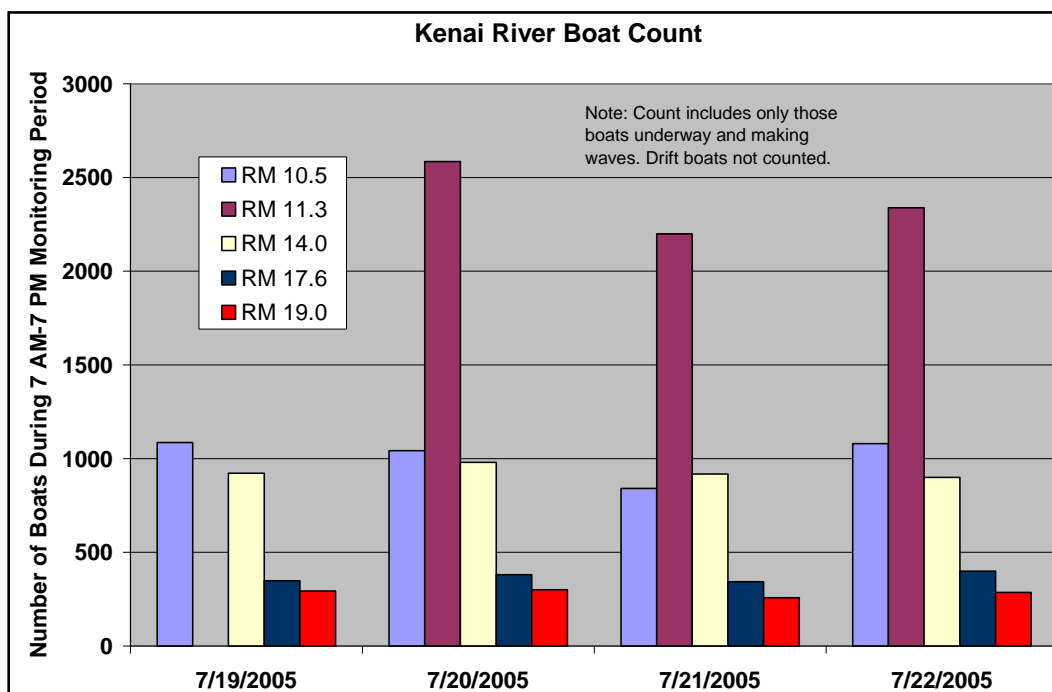
Figure 15. Number of boats passing by each site for each 12-hr monitoring period. Does not include boats not making waves such as drift boats. Note that data were not taken at RM 11.3 on 19 July 2005.

The numbers of boats counted by site and for each 12-hr monitoring period are shown in Figure 15. Note that the sites can be grouped into three categories. The first category has two sites (RM 19.0 and 17.6) having low levels of boat traffic averaging about 325 boats per 12-hr monitoring period. The second group has two sites (RM 14.0 and 10.5) having medium levels of boat traffic averaging about 970 boats per 12-hr monitoring period. The third category has one site (RM 11.3) having high levels of boat traffic averaging about 2,375 boats per 12-hr monitoring period.

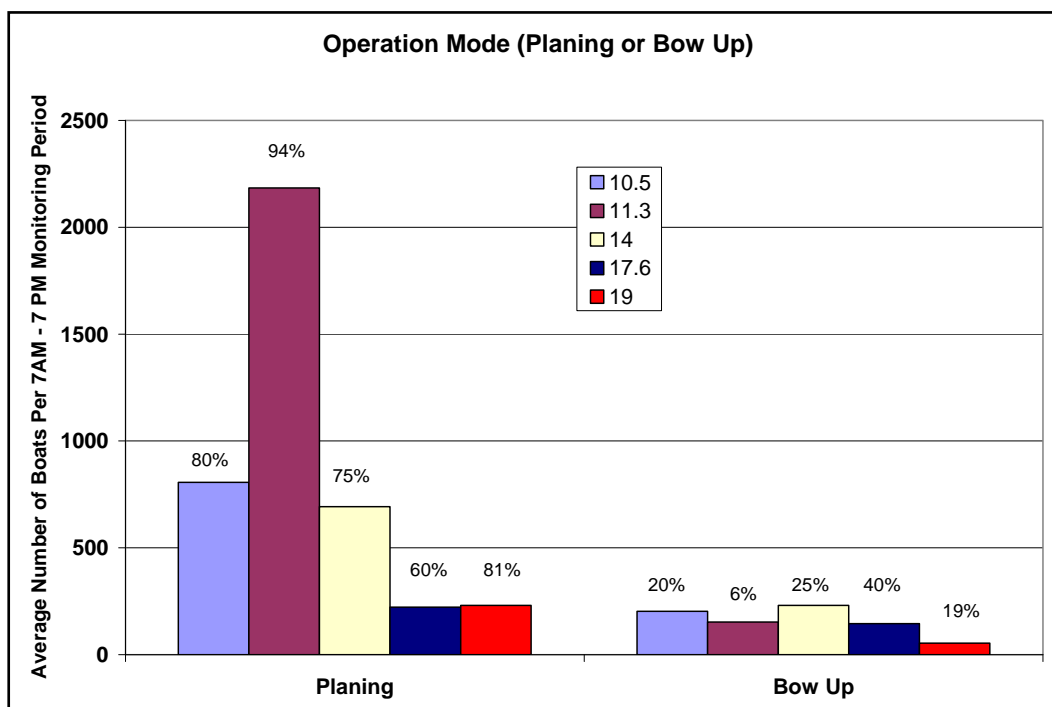
Figure 16. Boat operation mode by site based on average number of wave-making boats per 12-hr monitoring period. Bow Up refers to boats plowing through the water and operating at slower speeds that generally make the largest waves. Does not include boats not making waves such as drift boats. Planing is also referred to as “getting on step.”

Figure 16 shows the breakdown of operation mode for each site based on the average number of boats per 12-hr monitoring period. Bow up refers to operation at slower speeds and larger boat wakes and is visually characterized by the bow higher than the stern. Planing mode has higher speeds and smaller boat wakes and is visually characterized by the bow being only slightly higher than the stern. While some boats could be planing with large trim angles, this was not frequently observed and would have been difficult for the observers to determine. At all sites, the majority of boats were planing. RM 17.6 has the largest percentage of boats that operated in the bow up mode whereas RM 11.3 has the lowest.

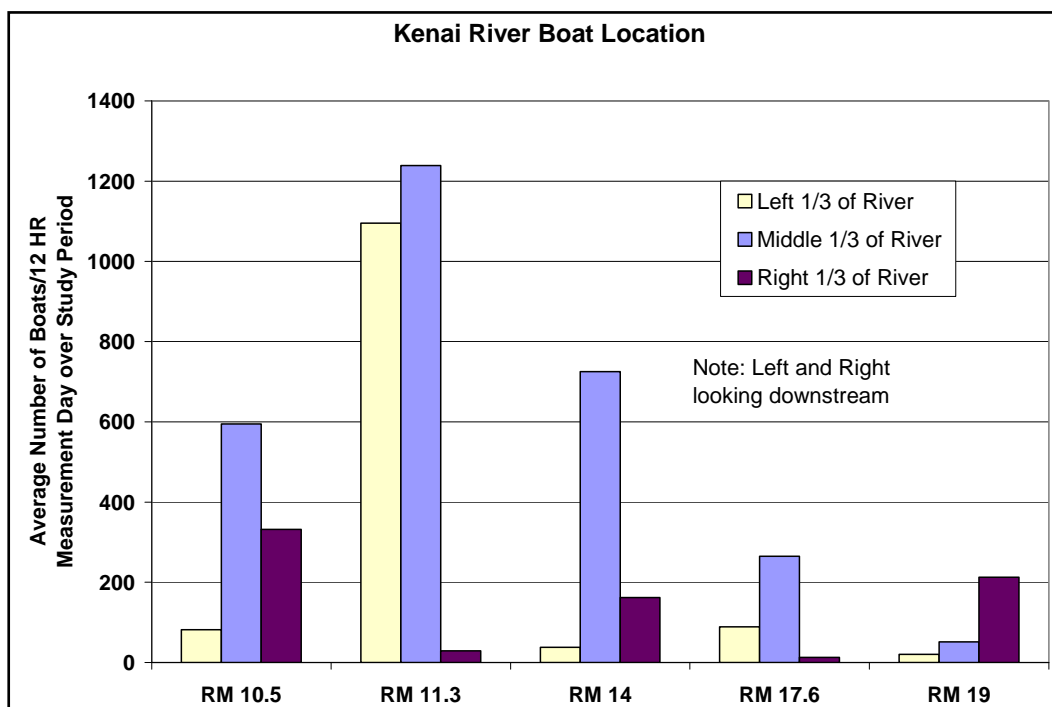
Figure 17. Boat location across the channel by site based on average number of wave making boats per 12-hr monitoring period.

Figure 17 shows the lateral position of boats by site based on the average number of boats per 12-hr monitoring period. The boat counters were asked to record the lateral position of each boat based on dividing the channel into thirds of close (C), middle (M), or far (F). This type of observation was difficult at RM 19 because the observation site was close to the level of the water. At other sites, the observers were some distance above the water level and characterizing the lateral position was somewhat easier, particularly at RM 14 where the observation location was about 30 ft above the water level. The observers were told that, if a boat was on the borderline of M and F or M and C, the entry could be FM or MC. At all river miles except RM 11.3, the observers used very few designations of FM or MC. At RM 11.3, many boats were observed at FM because the majority of all boats were traveling on the far half of the channel that was toward the left descending bank at RM 11.3. To place the FM into either an F or an M classification used in Figure 17, one-half the FM were placed in F and one-half were placed in M. Lateral positions having almost no traffic, such as the right one-third of the channel at RM 11.3, reflect that this portion of the channel width is a drift area that is generally not used for boats motoring through the reach.

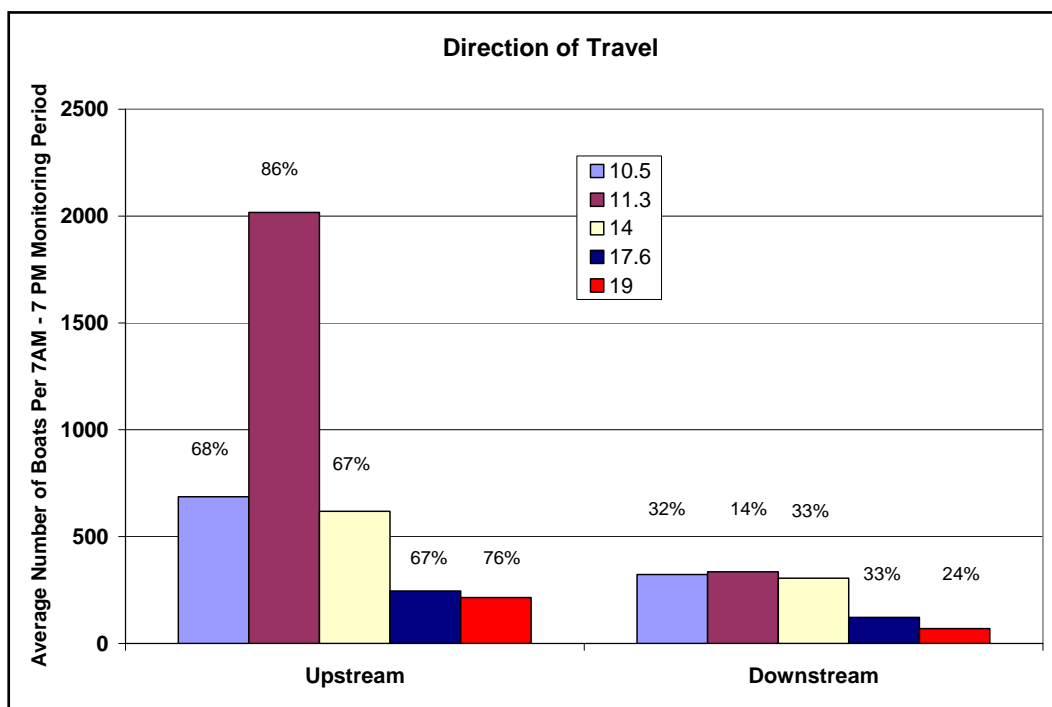
Figure 18. Direction of boat travel by site based on average number of wave-making boats per 12-hr monitoring period. The percentage shown refers to the percent of boats at that site going in the specified direction. Plot shows that most wave-making boats are going upstream.

Figure 18 provides the distribution of boat travel direction. The dominant direction of travel for boats underway and creating waves is upstream because much of the fishing is done by drifting downstream. Nowhere is this more evident than at RM 11.3, which is the middle of the major drift area in the study reach. Studies in Maynard (2001) showed that planing conditions resulted in the same maximum wave height for upstream and downstream boats, but the upstream boats had greater period and thus greater energy on the bank. For boats in the bow up mode of operation, both maximum wave height and wave period were higher for upstream boats.

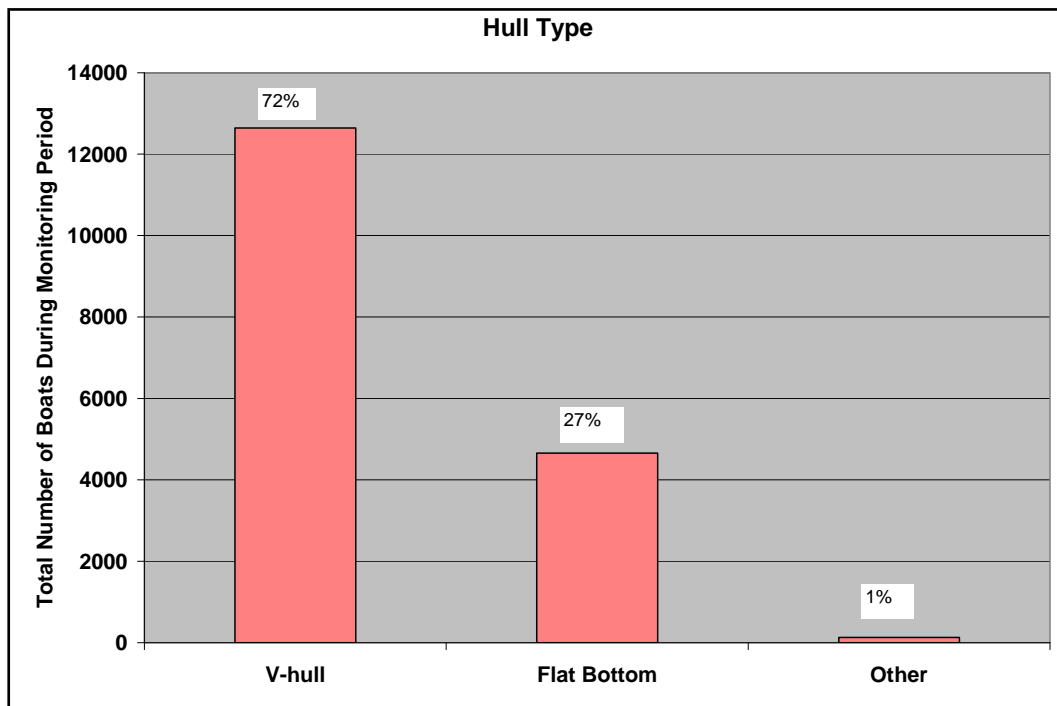
Figure 19. Variation of hull type based on all sites and all dates.

Figure 19 shows the variation of hull type based on v-hull, flat bottom, and other. V-hull boats are 72 percent of all boats on the river, flat bottom are 27 percent, and other hull types are 1 percent. The data did not show any significant variation of hull type based on site location, and all sites and all dates were lumped together.

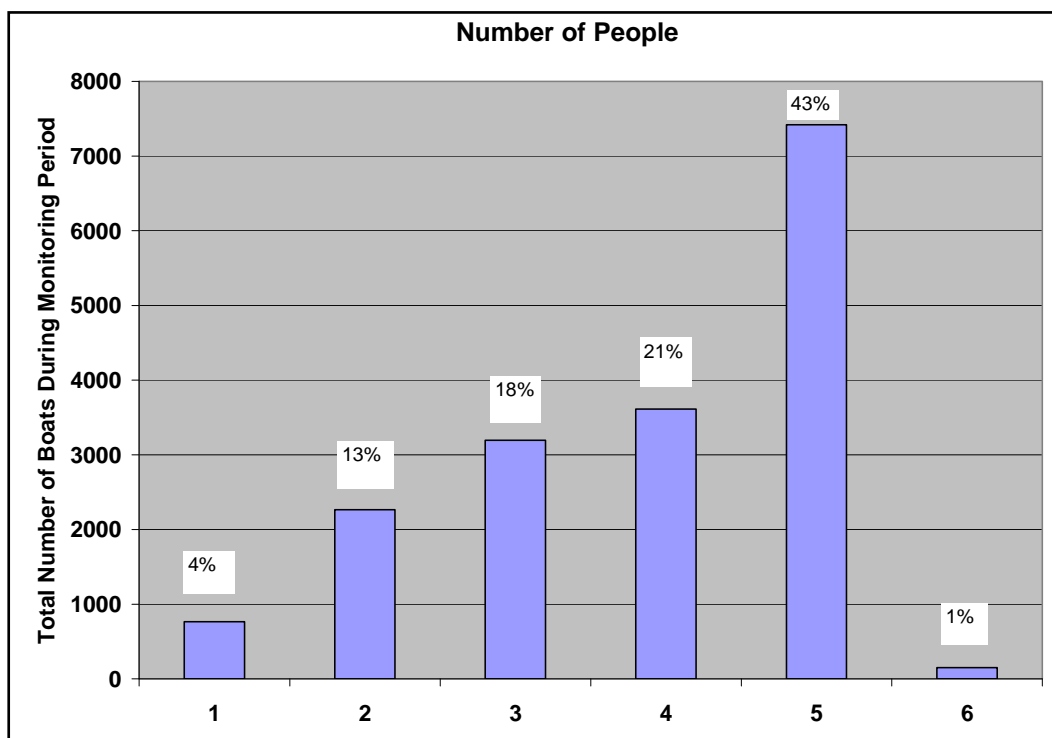
Figure 20. Variation in number of people in boat based on all sites and all dates.

Figure 20 shows the variation of number of people in a boat. Almost one-half of the boats (43 percent) contained five people. The data did not show any significant variation in number of people based on site location, and all sites and all dates were lumped together.

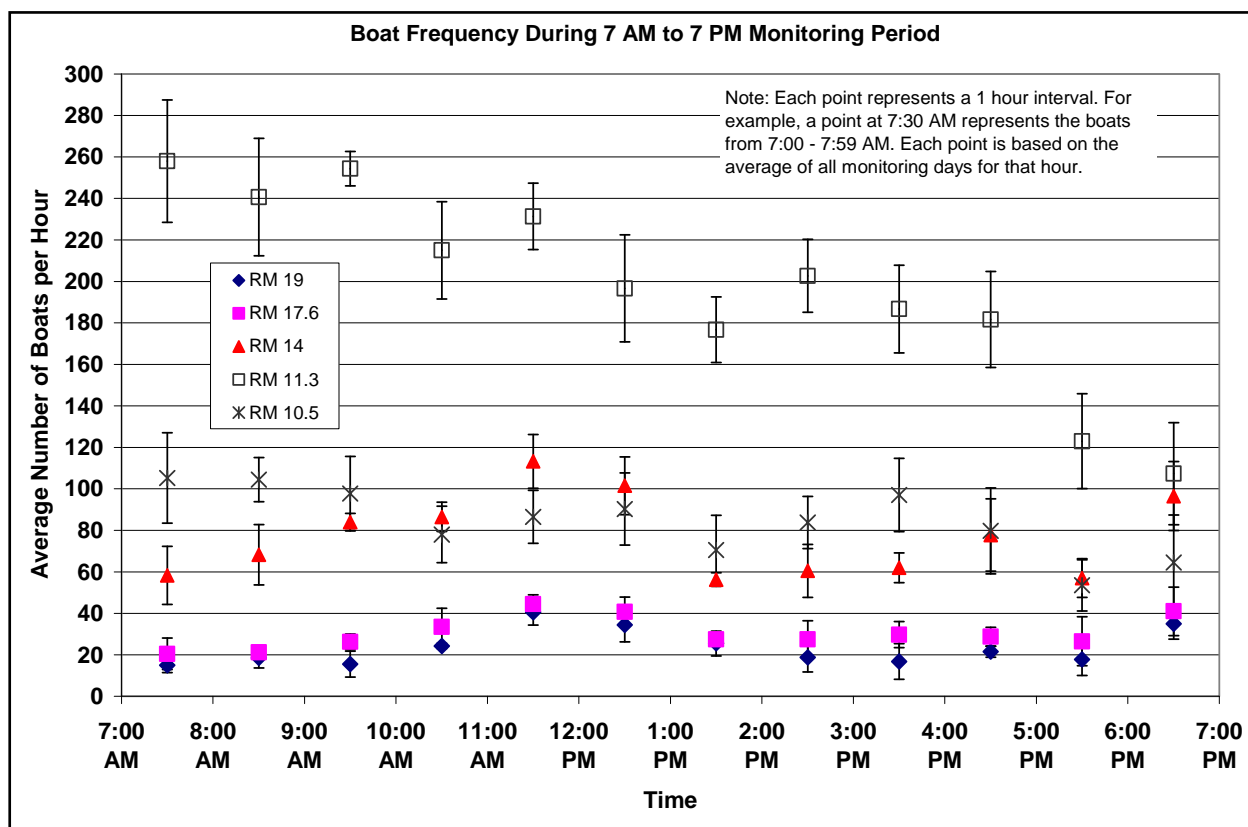
Figure 21. Wave-making boat passage frequency variation during 7AM to 7PM monitoring period. Each point is the average of that hour from the 4 days of boat counts except for RM 11.3, which was counted on only 3 days. Error bars are  $\pm$  one standard deviation.

Traffic variation during the day is shown in Figure 21. All sites except RM 11.3 show a relatively consistent amount of traffic with small peaks at lunch and at the end of the day. The drift area at RM 11.3 shows peak traffic in the early morning and decreasing traffic throughout the day. One explanation is that the tidally influenced reaches have less successful fishing during high tides. During the monitoring period from 19 to 22 July, the daytime high tide was generally after about 1500 hr.

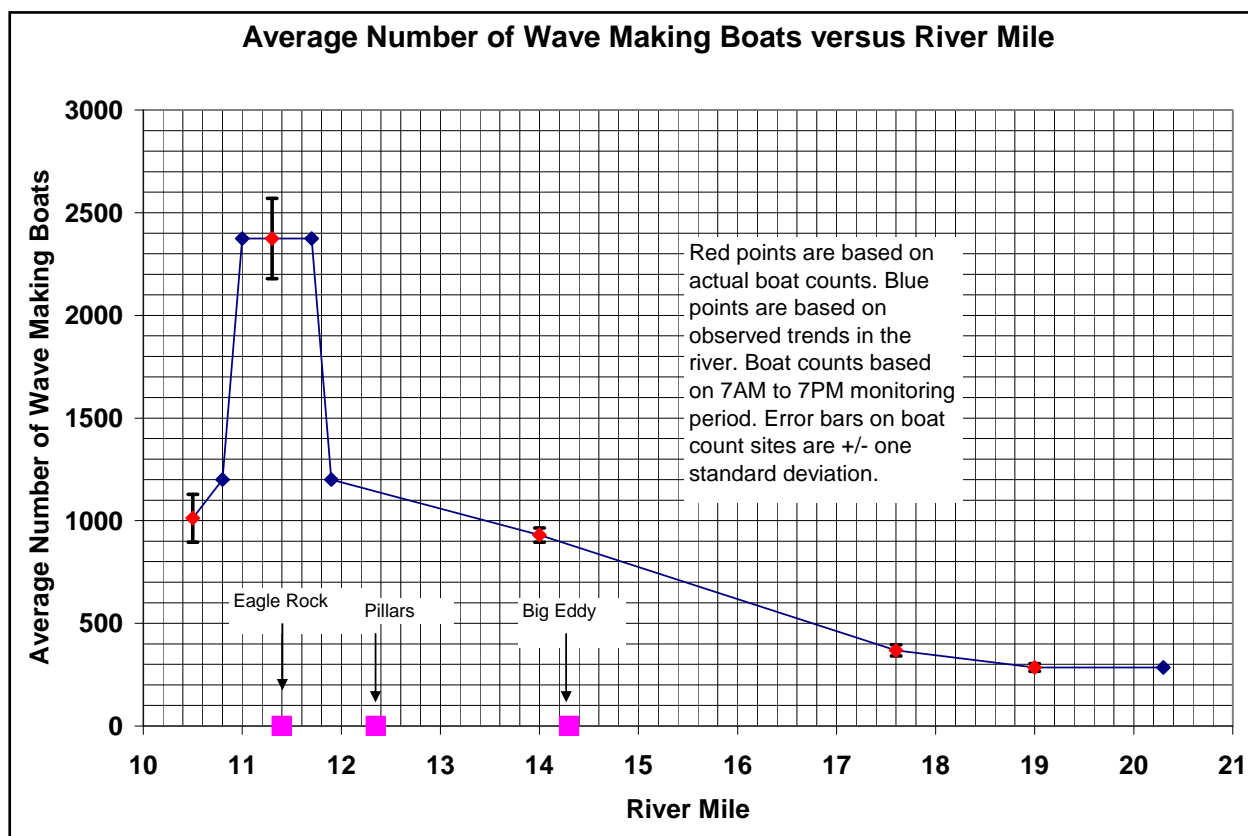
Figure 22. Variation of average number of wave-making boats along study reach per 12-hr monitoring period. Red boat count points based on average of total boats on each of 4 days during field study except for RM 11.3, which was based on 3 days. The blue points based on observed trends are based on turn around points at a drift area or locations of boat launch points.

Figure 22 shows the variation of average boat traffic along the 11-mile reach. The plot is based on data from the five boat count locations as well trends observed by persons knowledgeable of boat traffic on the river. The trend points are necessary because it was not possible to have enough boat count sites to capture all variations along the river. The trend points are based on turn around points in the major drift area as well as a boat launch point at the upstream end of the study reach. The plot is most representative of the 19-22 July 2005 monitoring period. Only the major drift area at RM 11.3 is included because it was not possible to staff enough count teams to describe all variations in traffic along the reach. Figure 22 will be used to assess boat wave energy variation along the river.

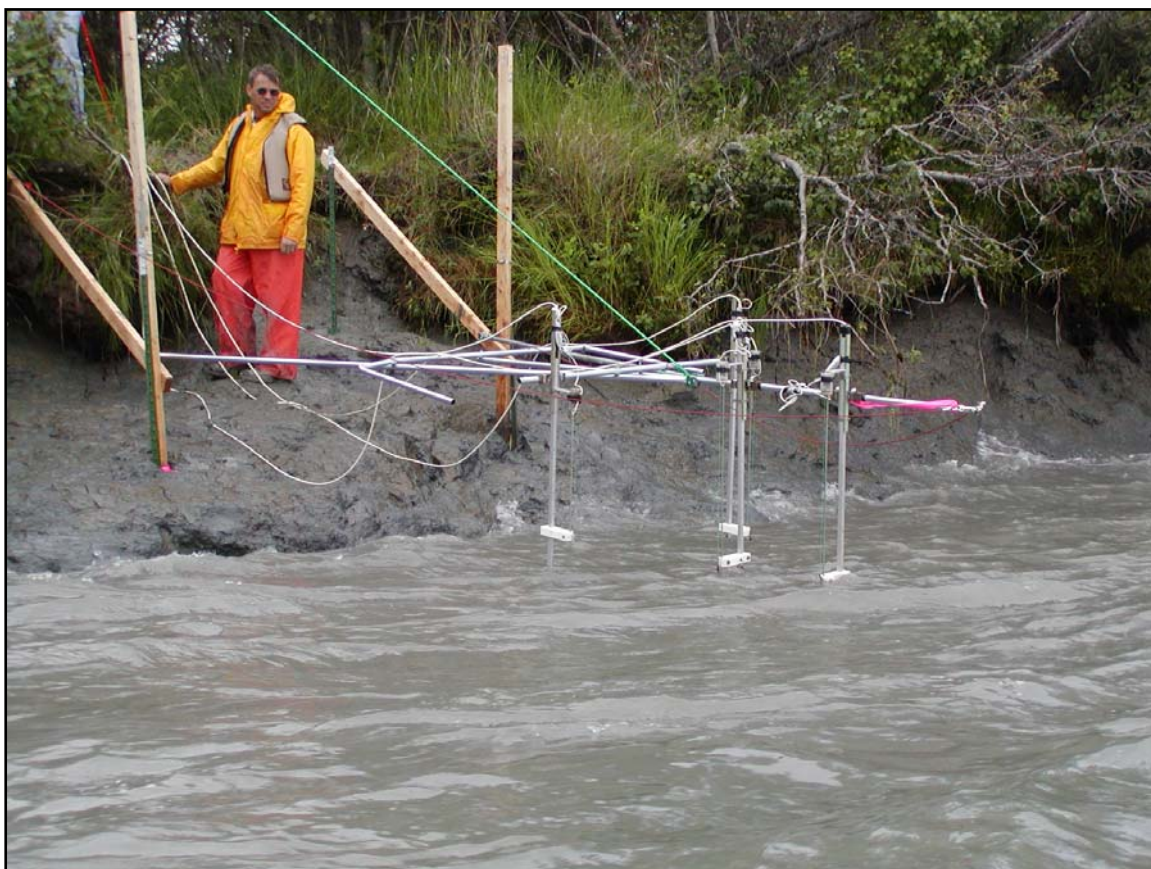
Figure 23. Wave stand supporting four wave rods used in wave measurements at RM 10.5. This site is on the left bank (looking downstream) about 0.5 mile upstream of Beaver Creek. Green rope used to raise and lower wave stand for installation, repair, and cleaning of gages as well as raising and lowering to deal with varying water level due to tides.

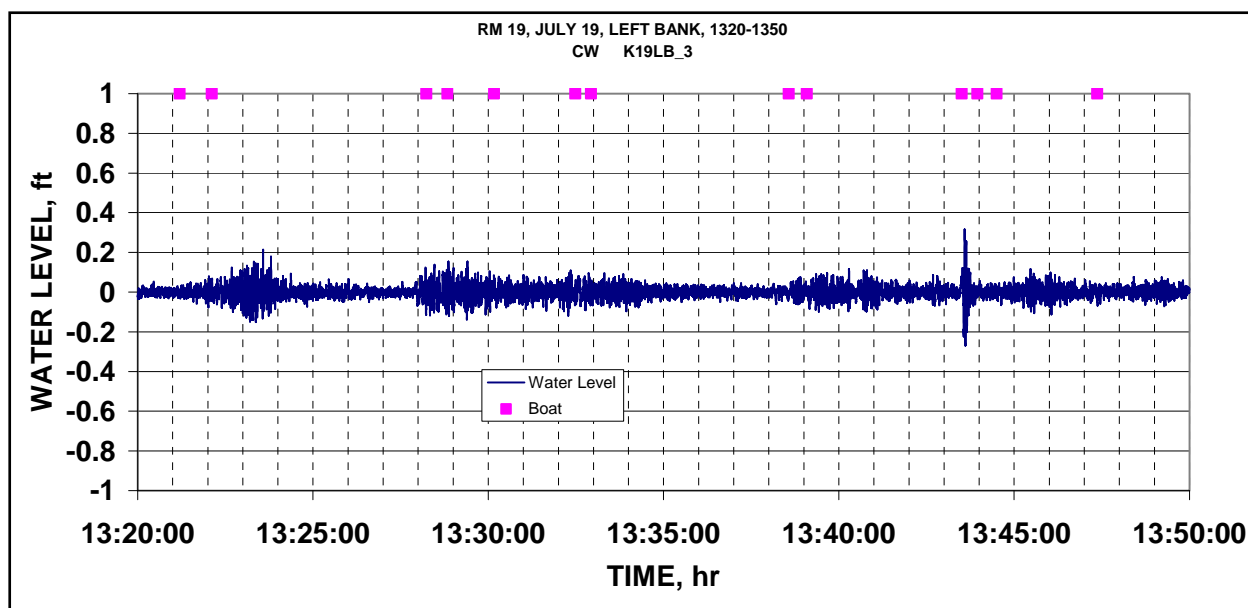
Figure 24. Water level and boat passage at RM 19, left bank, 19 July, 1320-1350.

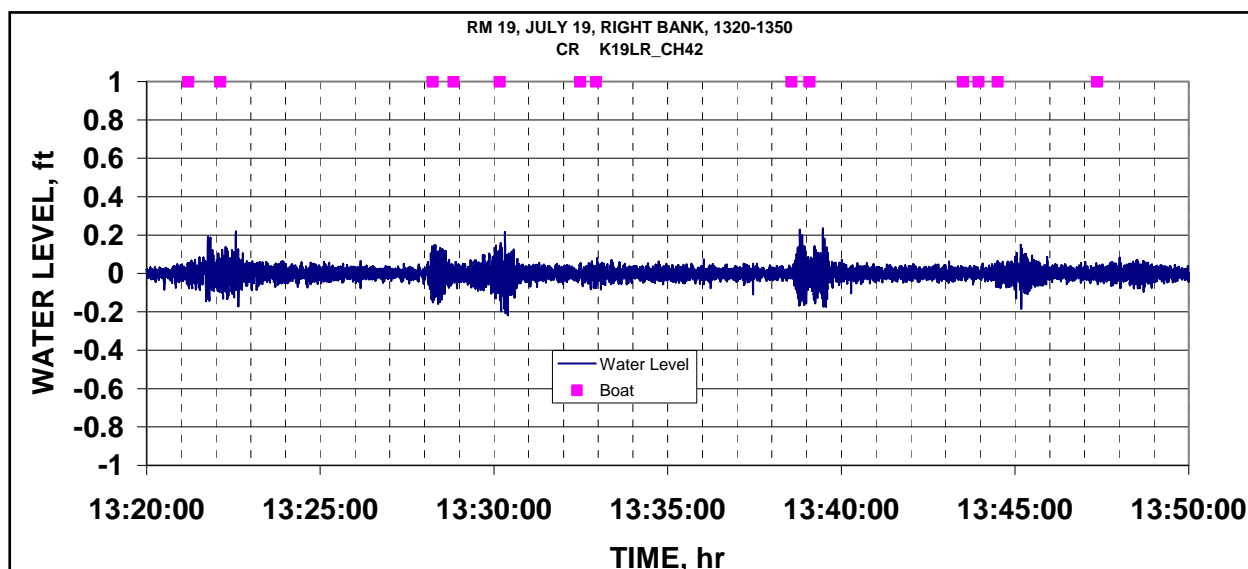
Figure 25. Water level and boat passage at RM 19, right bank, 19 July, 1320-1350.

Figure 25 shows the same time window on the right bank at RM 19. Table 6 shows the boat characteristics recorded from the left bank during the 1320-1350 time window at RM 19.

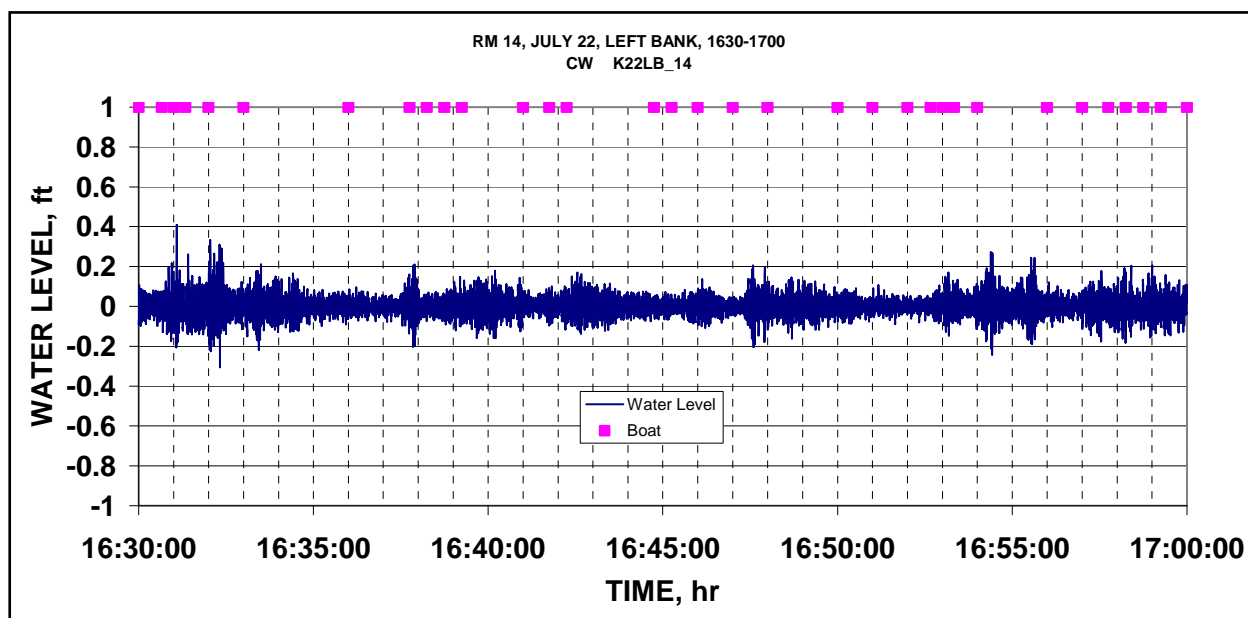
Figure 26. Water level and boat passage at RM 14, left bank, 22 July, 1630-1700.

Figure 26 shows measured water level and boat passage time for 33 boats at the left bank at RM 14 on 22 July between 1630 and 1700. Figure 27 shows measured water level and boat passage time for 95 boats at the right bank at RM 11.3 on 21 July between 1153 and 1223. Figure 28 shows measured water level and boat passage time for 32 boats at the left bank at RM 10.5 on 20 July between 1330 and 1400.

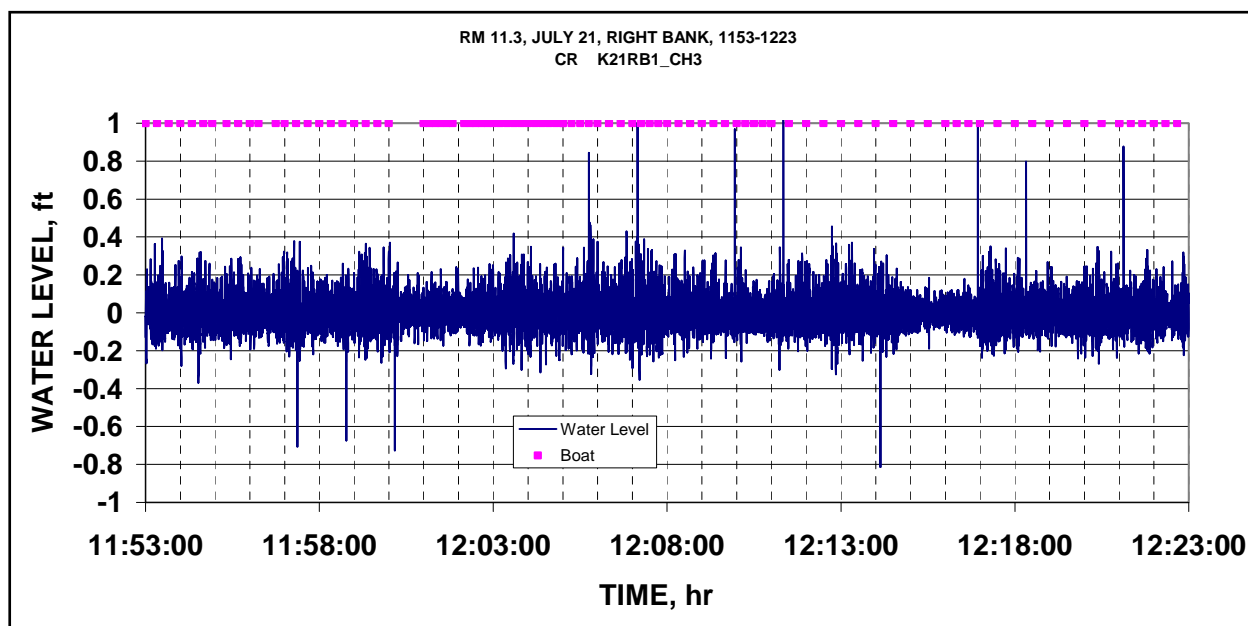
Figure 27. Water level and boat passage at RM 11.3, right bank, 21 July, 1153-1223.

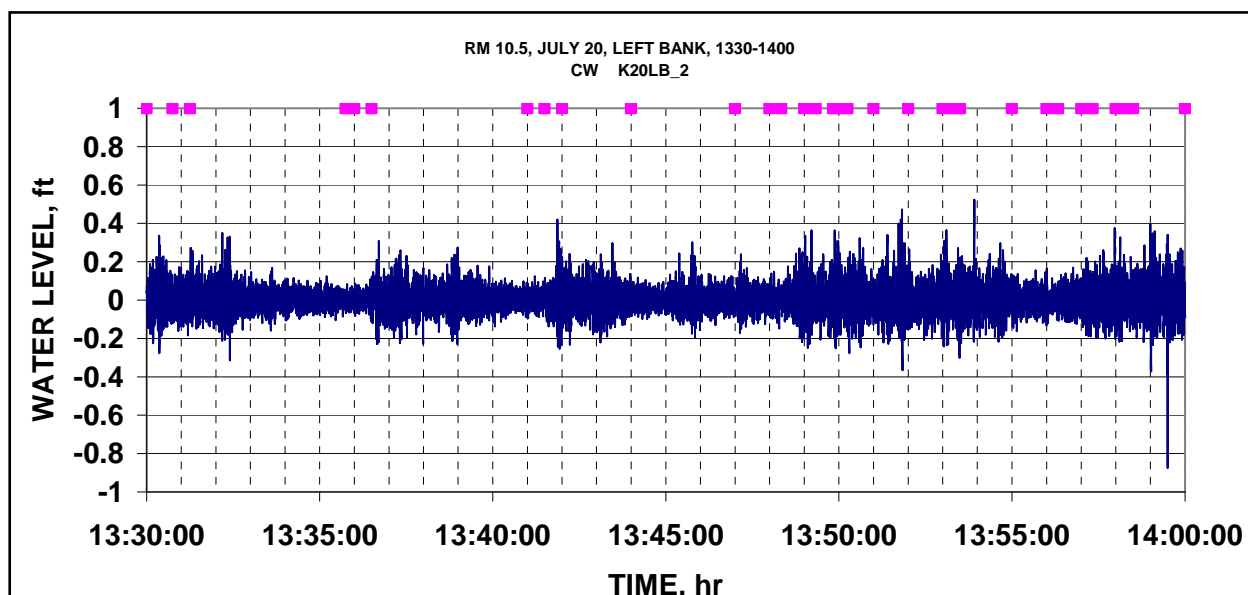
Figure 28. Water level and boat passage at RM 10.5, left bank, 20 July, 1330-1400.

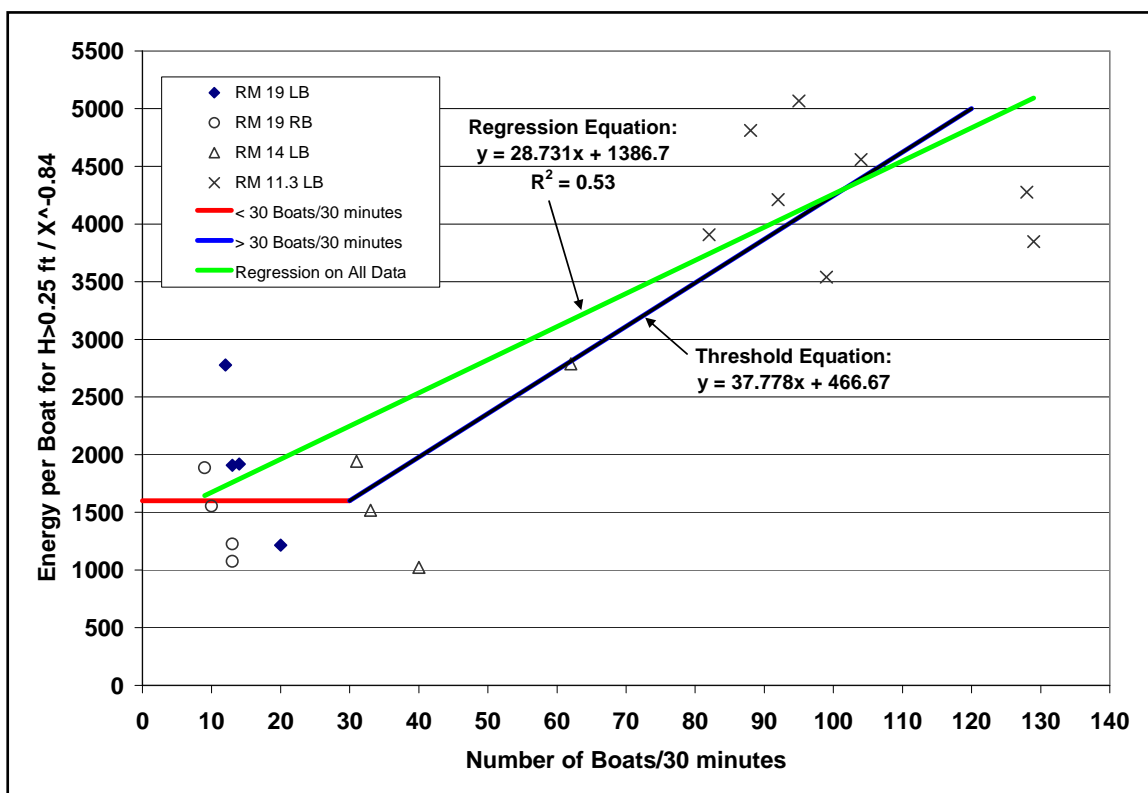
Figure 29. Boat wave energy per boat/ (distance from shoreline to average sailing line)<sup>-0.84</sup> versus number of boats in 30 min.

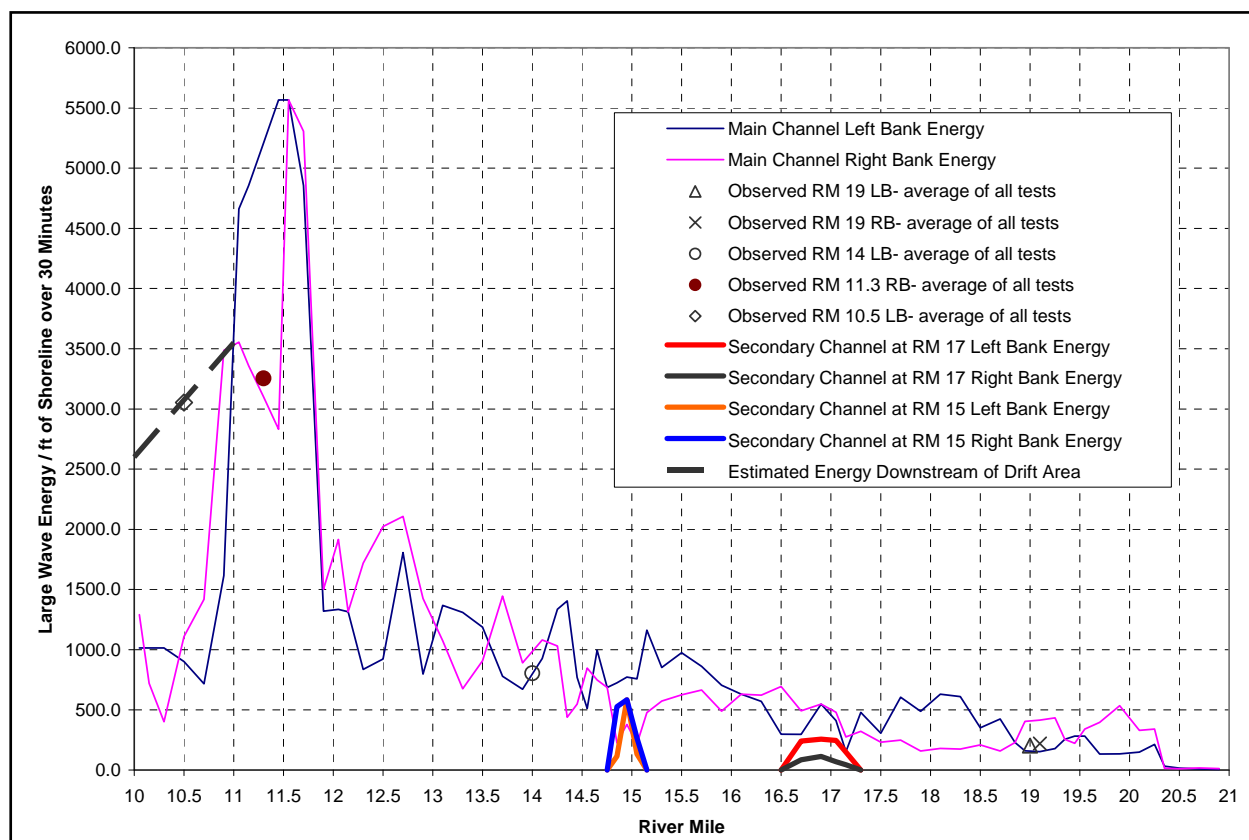
Figure 30. Variation of large ( $> H=0.25$  ft) boat wave energy along study reach based on boat wave energy equation.

Using Figures 1-4, the study reach was divided into 69 reaches that were 0.1 or 0.2 mile long based on similar location of the average boat path. For each reach, the distance from the average boat path to the left and right shorelines was determined from Figures 1-4. From Figure 22, the average daily traffic was determined for each reach and that value was converted to an average number of boats per 30 min. Equation 9 or 10 was used to compute the boat wave energy for  $H > 0.25$  ft per boat for each reach. The boat wave energy/boat was converted to boat wave energy over the 30-min period by multiplying by the number of boats during that period. Results are shown in Figure 30 and Table 8. Figure 30 also shows the observed data, including the data point at RM 10.5 that was not used in development of the boat wave energy equation. As expected, the boat wave energy equation does not do well at RM 10.5, likely because boats immediately upstream are getting on step in an upstream direction and feeding boat wave energy into RM 10.5 but not passing through the boat counting section. For purposes of determining boat wave energy trends, boat wave energy magnitude downstream of the drift area was estimated as shown by the dashed line in Figure 30. It is quite possible that the area from RM 10.5 to 11.0, where boats are leaving the drift and heading back upstream, has the highest boat wave energy at the shoreline of any site on the river. The boat wave energy equation is based on normal traffic conditions and does not take into account large numbers of boats getting on step. Figure 30 is intended to show trends of boat wave energy along the study reach and not absolute values.
